Detailed Unexploded Ordnance (UXO) Threat & Risk Assessment

6 ALPHA PROJECT NUMBER	SAMPLE	ORIGINATOR	R. Griffiths
LANDMARK ORDER NUMBER	SAMPLE	REVIEWED BY	B. Wilkinson
CLIENT REFERENCE	SAMPLE	RELEASED BY	L. Askham
SITE	Parsons North, Edgware Road, London, W2 1NE		
RATING	MEDIUM - This Site requires limited further action to reduce risk to ALARP during intrusive activities.

The Client has defined the Study Site as “Parsons North, Edgware Road, London, W2 1NE”. The Site is located at NGR 526630, 182110.

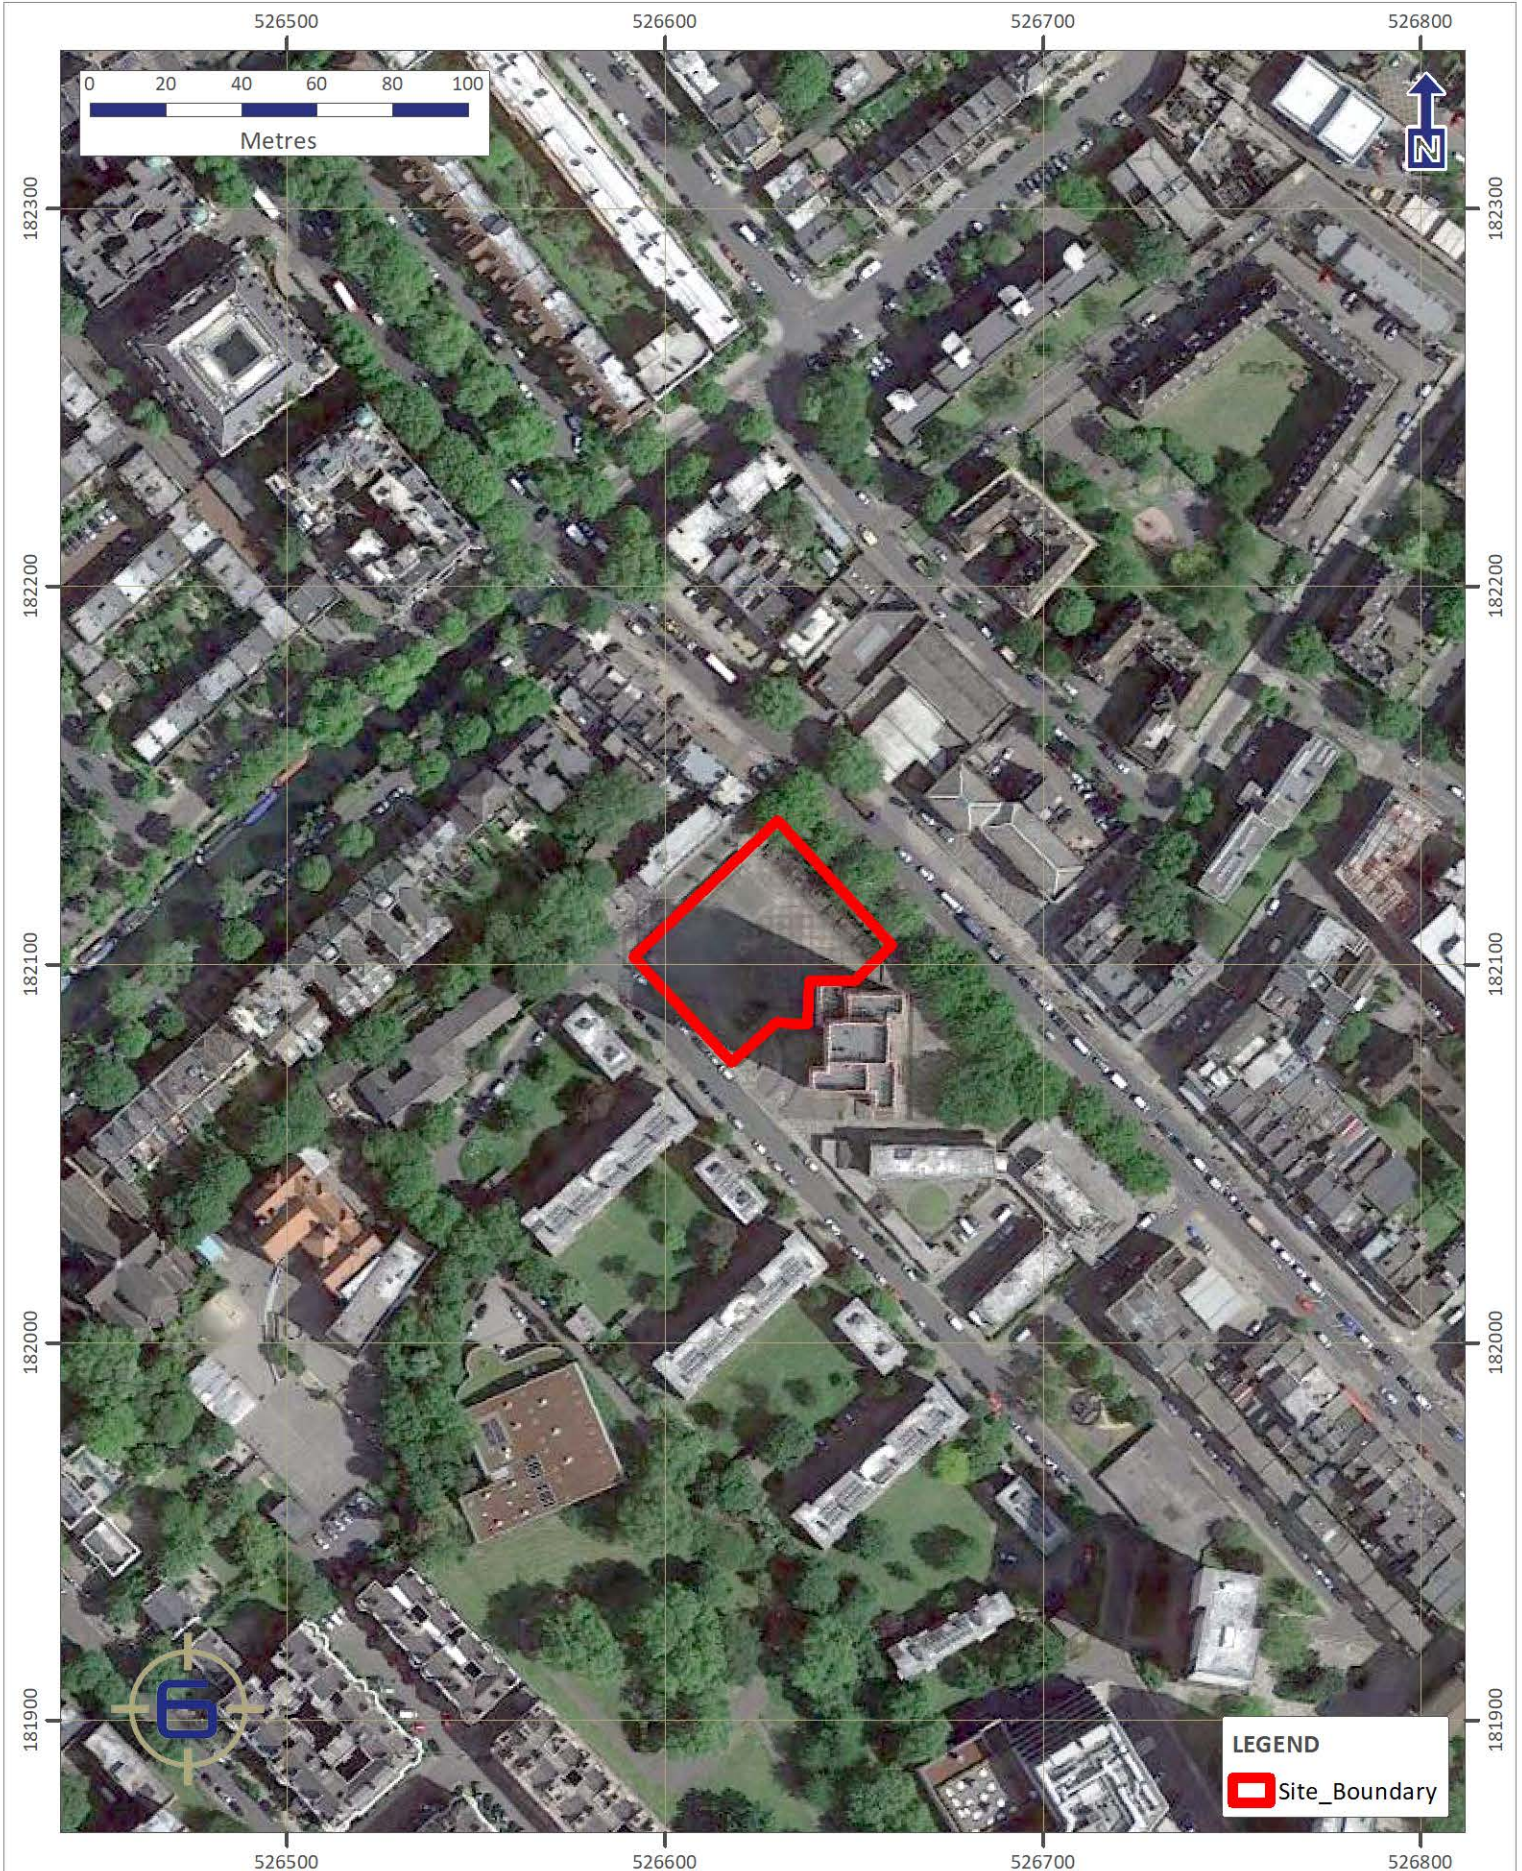
Aerial Photography (Current)

Current aerial photography shows that the Site is situated within a densely developed urban area and consists of hardstanding concrete, which serves as the roof of a basement car park below.

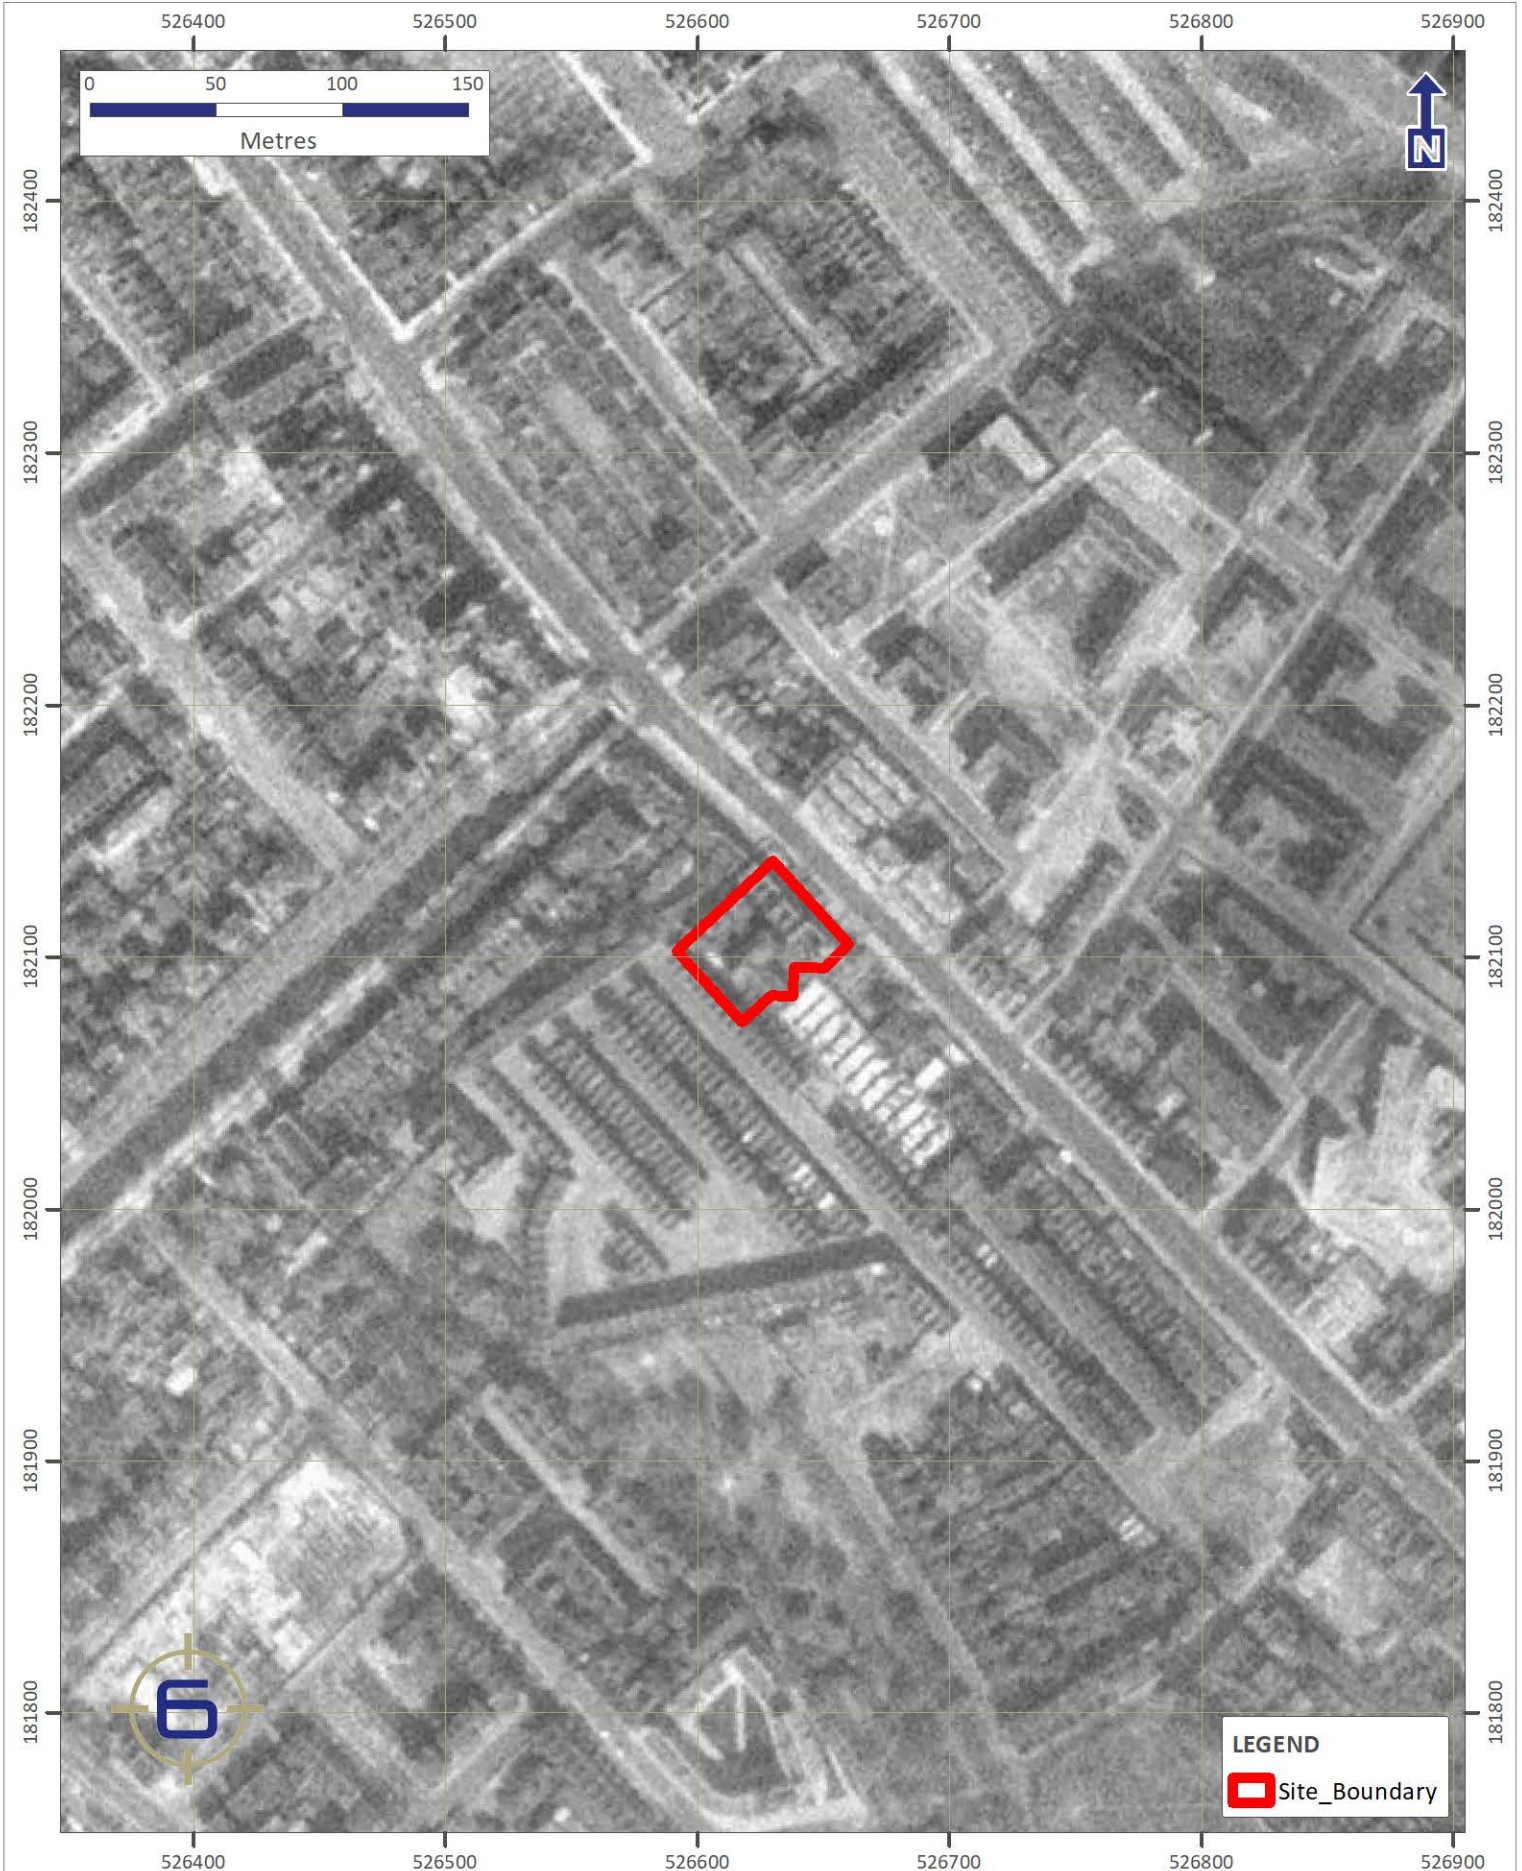
Aerial Photography (1945)

The aerial photography (1945) associated with the Site shows that it consisted of several small structures within a heavily developed area. That said, the resolution of the photograph is not sufficient enough to be able to accurately identify the features and/or structures within the Site at that time.

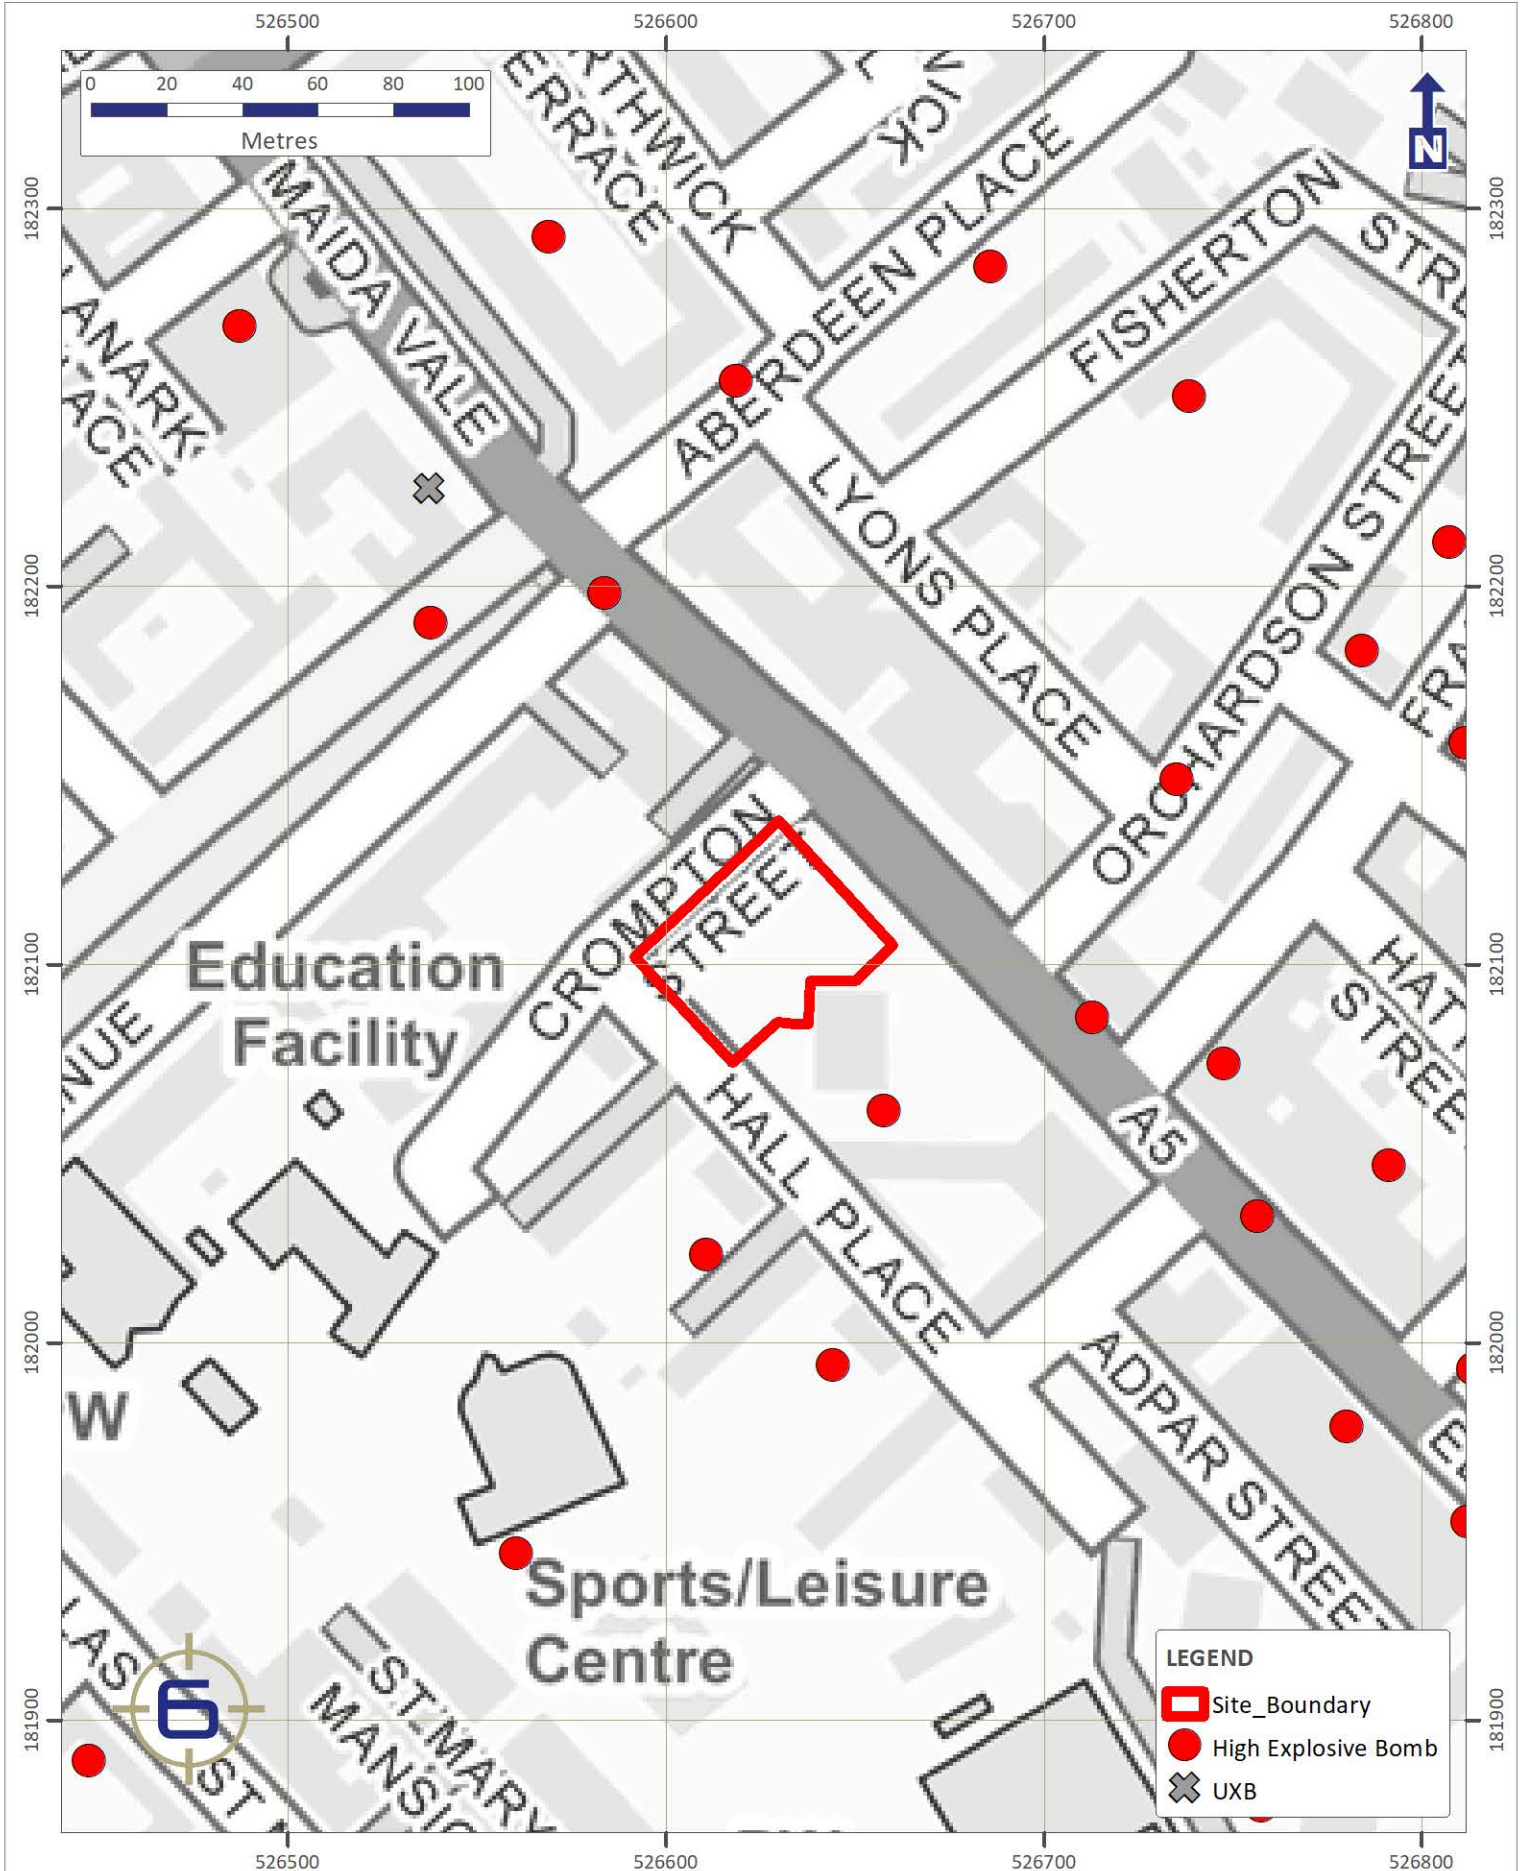
WWII High Explosive Bomb Strikes

During WWII, ARP wardens compiled detailed logs of bomb strikes across their respective districts. ARP records associated with the Site did not register any HE bomb strikes within it, nonetheless seven were recorded within 100m; approximately 30m to the south-east, 50m to the south, 55m to the east-south-east, 75m to the north-north-east, 85m to the south-south-east, 85m to the north-east and 95m to the south-east. Furthermore, whilst IBs may have fallen within the Study Site, they fell in such large numbers they were considered ubiquitous and accurate record keeping was either non-existent or perfunctory therefore, from an examination of the records, their prospective presence cannot be either corroborated or discounted.

In addition to IBs and HE bomb strikes, during the latter part of the war when aerial bombing had significantly declined, the main threat came from 'V' type weapons. These rockets were thin-skinned, unmanned and inaccurate weapons. ARP records identify a V1 rocket 360m to the north-east of the Site.

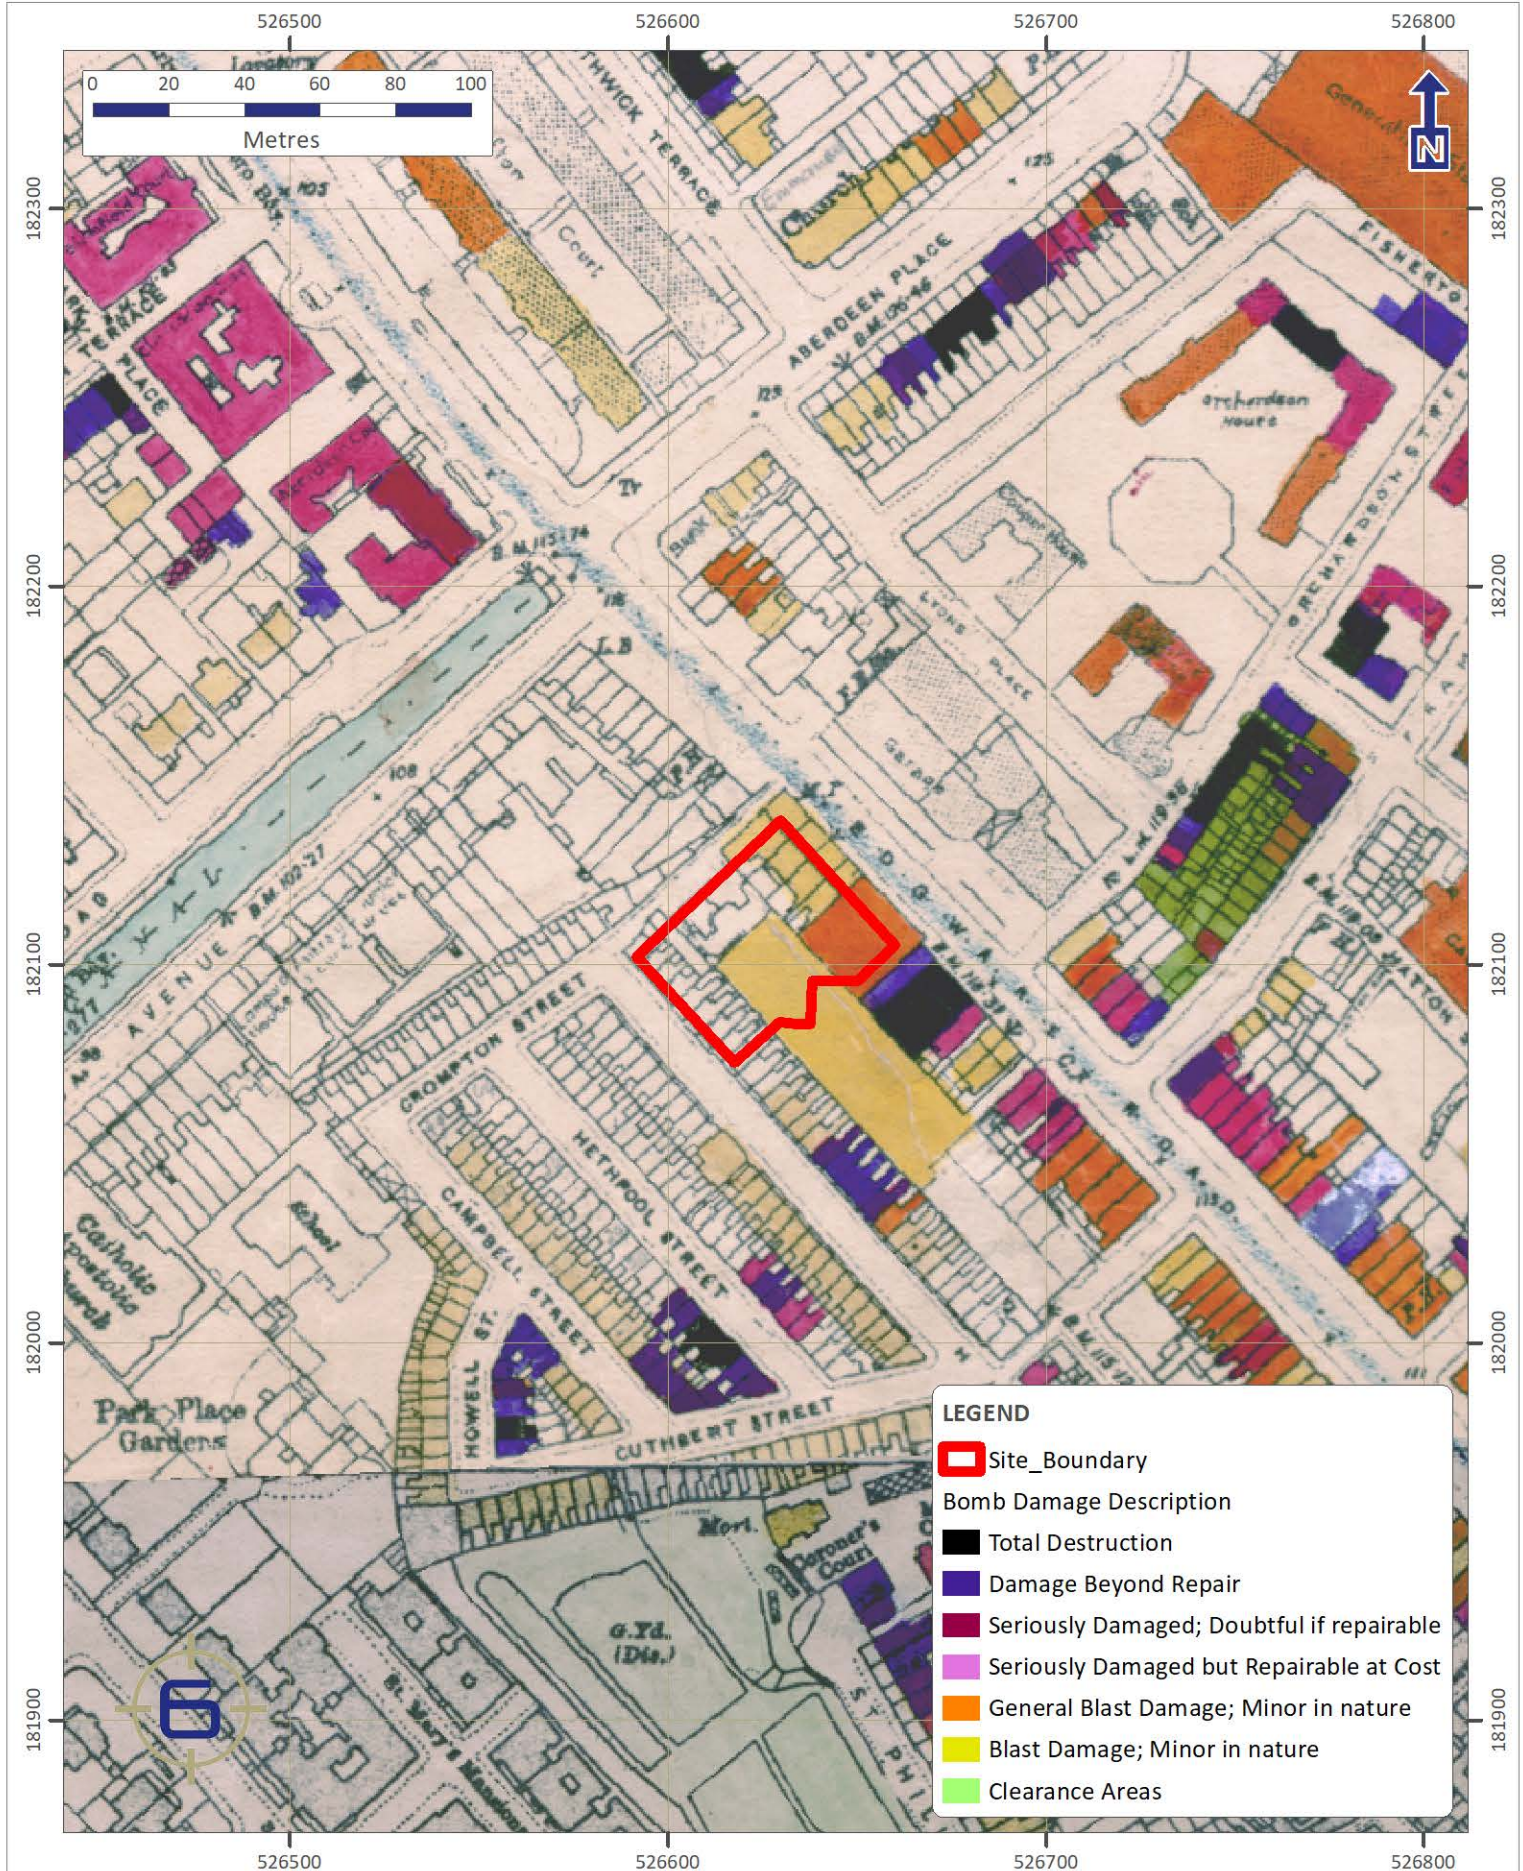
London County Council WWII Bomb Damage Map

An analysis of the LCC bomb damage maps associated with the Site identifies "blast damage, minor in nature" and "general blast damage – not structural" to buildings located within the Site. In addition, "damage beyond repair" and "total destruction" were recorded to buildings located immediately to the south of the Site.

Furthermore, an analysis of the post-WWII mapping associated with the area shows numerous "ruins" within the Site's vicinity, which is likely to be attributed to bombing.

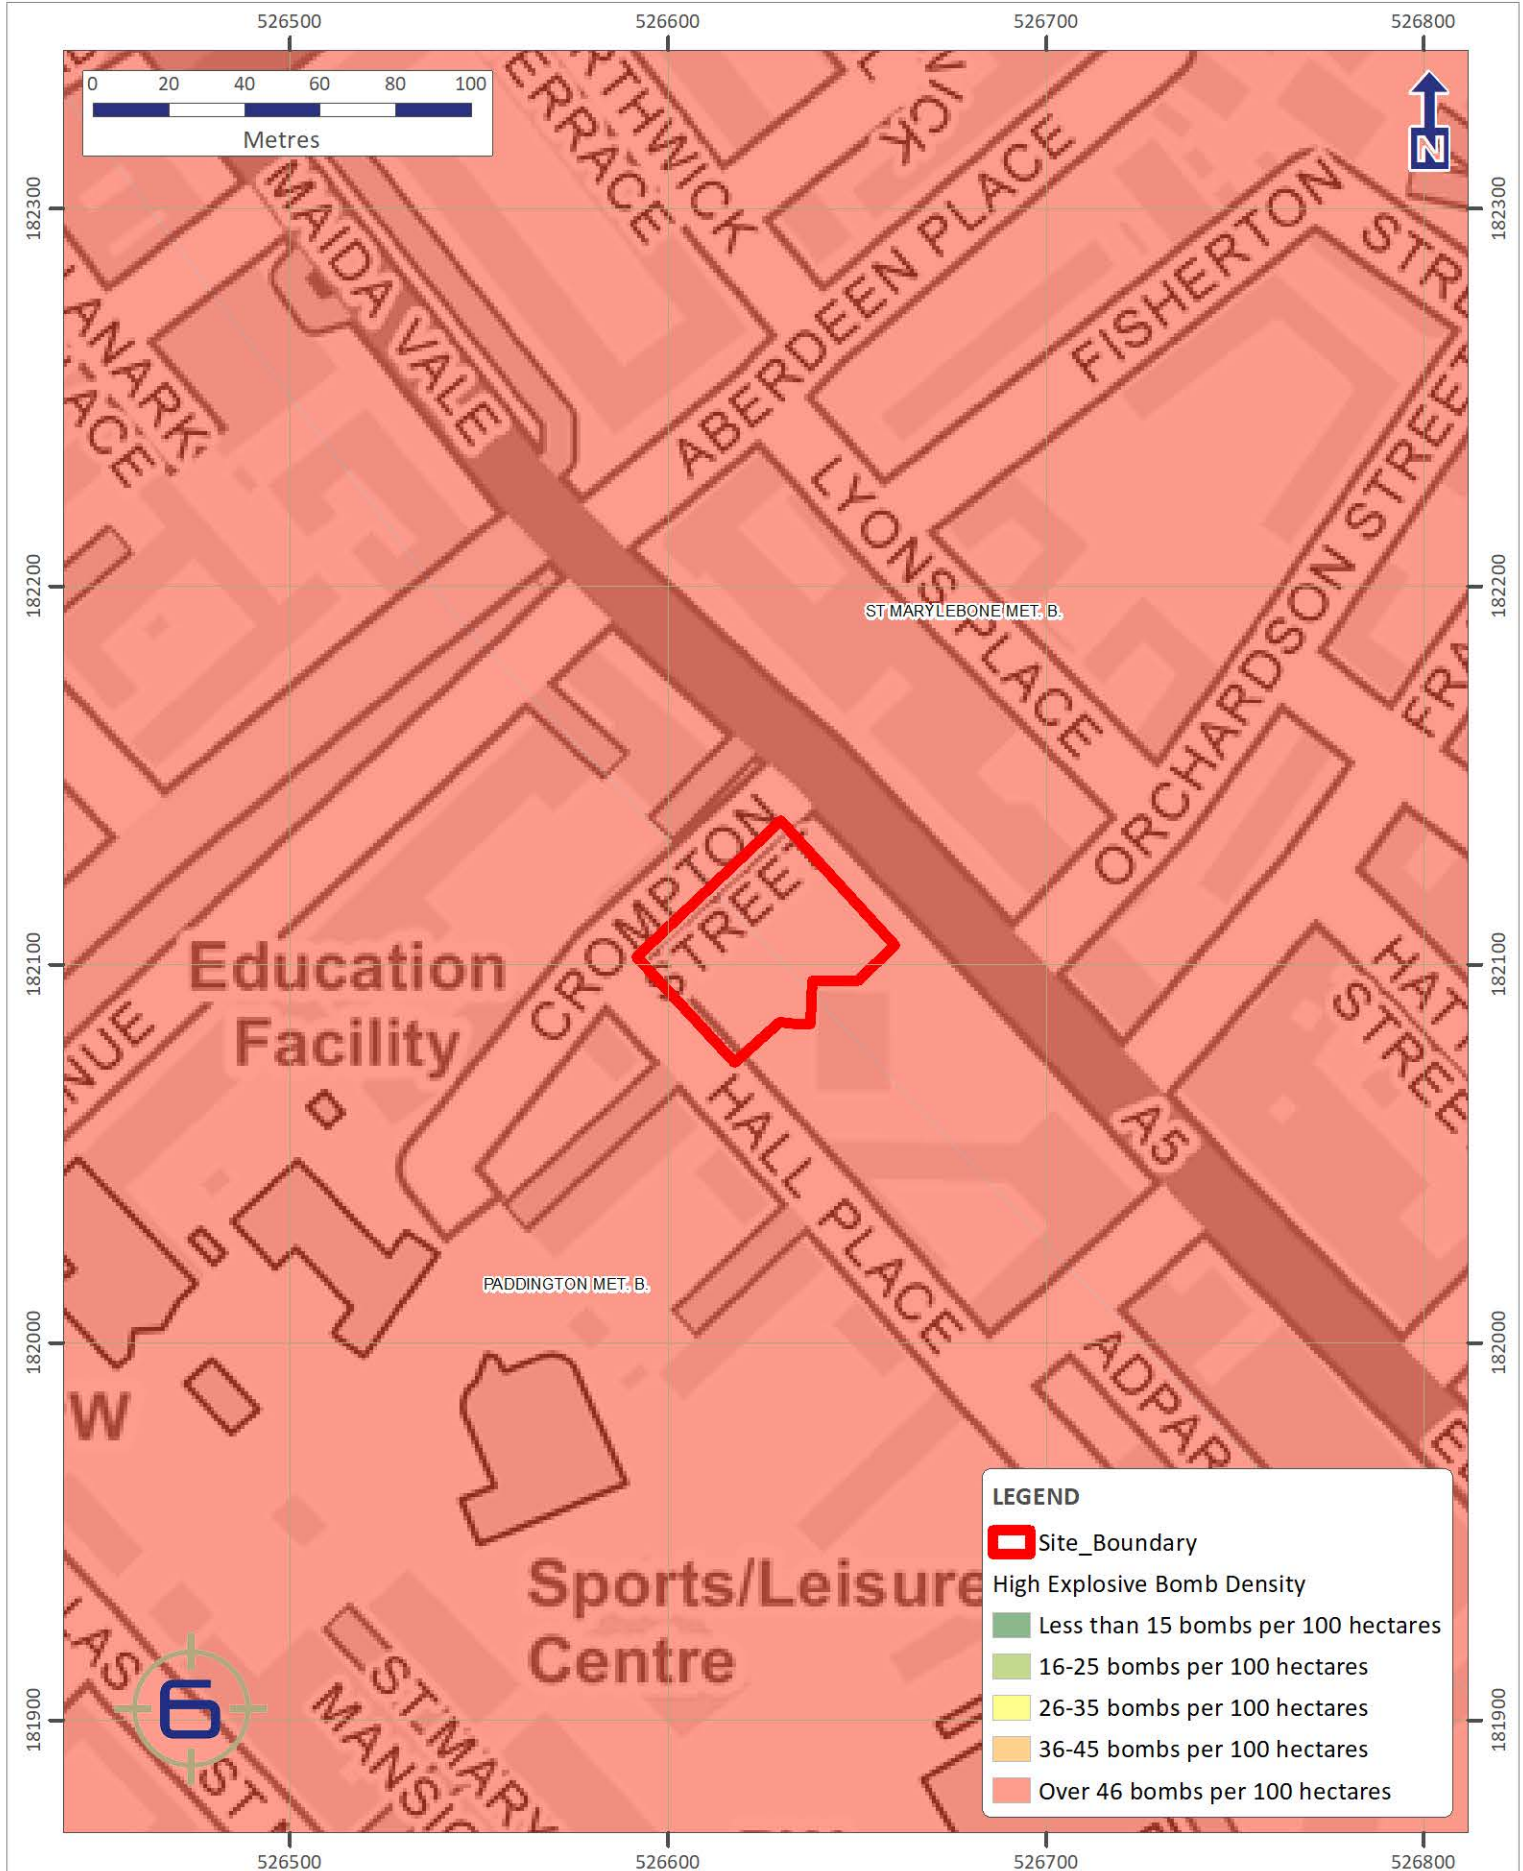
WWII High Explosive Bomb Density

The Study Site was located within the *Paddington Metropolitan Borough* and *St. Marylebone Metropolitan Borough*, which recorded 54 and 67 HE bombs per 100 hectares respectively, both very high levels of bombing
