Martello®

ADDRESS
Old Coach Road, Bodmin, PL30 5JA

RESIDENTIAL
Mines and Minerals

REFERENCE
MM/METALLIFEROUS-CMC/RED/20260513-01

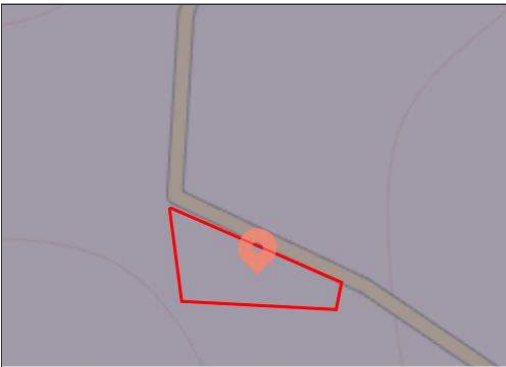
METALLIFEROUS

The property lies in an area of historic metalliferous mining activity and we have identified specific hazards that might cause ground instability. The likelihood that metalliferous mining subsidence might impact the property is high; however, further assessment can quantify or eliminate this threat.

- Expert opinion confirms the risk from Metalliferous mining activity is high

Our detailed review and appraisal of mining information has identified metalliferous mining hazards that might cause ground instability. Enquiries should be made with the vendor to see if the identified threats have been suitably addressed. We may be able to review any additional information to resolve the problem. Failing this, the Property should be investigated by a Mining Consultant to assess the risk, and any hazard mitigated, before the transaction can proceed.

Enquiries should be made with the vendor to see if the identified threats have been suitably addressed. We may be able to review any additional information to resolve the problem. Failing this, a Mining Investigation by a Mining Consultant is needed to assess the risk before the transaction can proceed.
