Sample Site, Sample Street, Anytown, UK

Professional opinion

Ref: Sample_GeoriskRes Your ref: Sample Grid ref: 123456 123456

Date: 22 February 2024

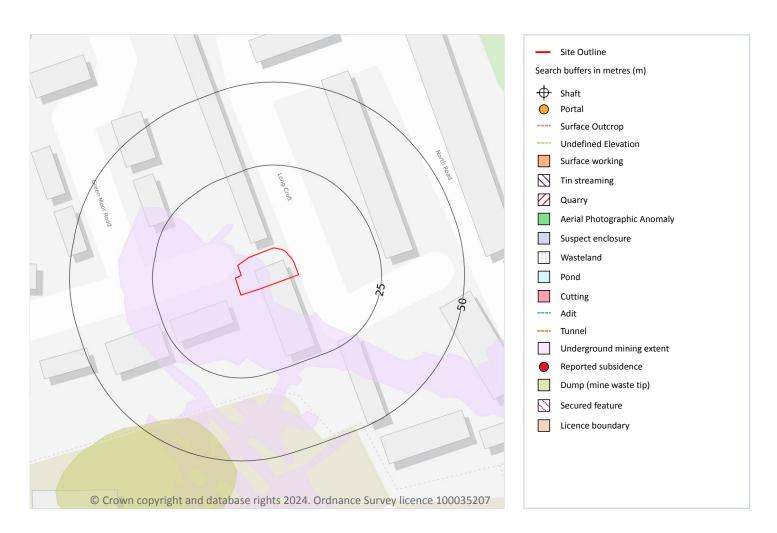
Non-coal mining / Mining features

Underground mine workings

Underground mine workings presenting a potential risk, including adits and seam workings, identified from BGS Geological mapping and mine plans sourced from the BGS and various collections and sources.

Location	Feature	Mineral	Mining type
On site	Underground mining extent	-	Unspecified
This data	a is sourced from Groundsure

Mine waste tips

Mine waste tips identified from OS, BGS Geological mapping, Lidar data, and mine plans sourced from the BGS and various collections and sources.

Location	Feature	Mineral	Mining type
40m SW	Mine waste tip	Copper	Metals

The property is underlain by ironstone workings at a depth of approximately approximately 55 metres below surface. Mining Searches UK have not confirmed the precise depth, stability and extent of these workings. There is the possibility of ground movement associated with these workings within the property.

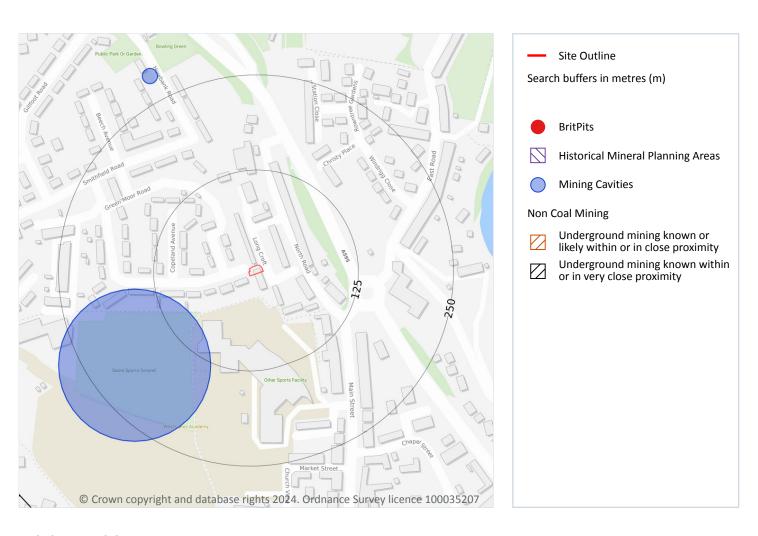
Non-coal mining / Mining records

Mining cavities

Industry recognised national database of mining cavities. Degraded mines may result in hazardous subsidence (crown holes). Climatic conditions and water escape can also trigger subsidence over mine entrances and workings.

Location	Mine Address	Mineral	Data source	Publisher
92m SW	Helder, Cumbria	Hematite	LISTING OF NEW MINERAL RECORDS OFFICE CATALOGUE.	UNPUBLISHED/DRAFT

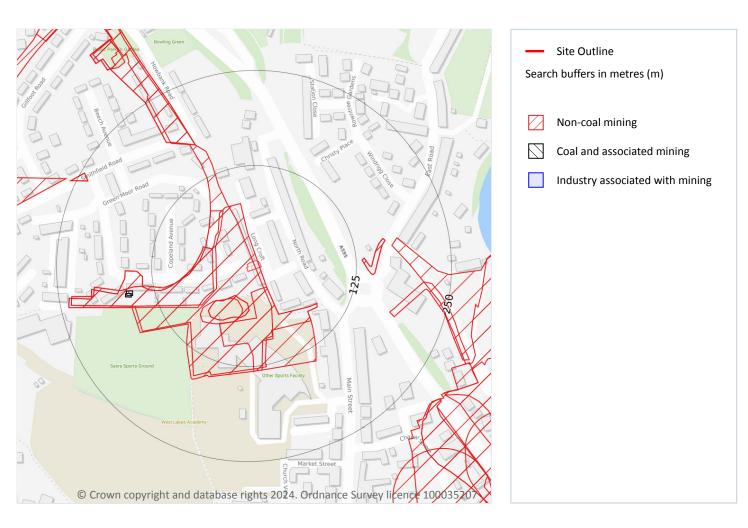
Non-coal mining / Historical features

Non-coal mining

Historical land uses identified from Ordnance Survey mapping that involved mining for substances other then coal.

Location	Land use	Date
On site	Iron Ore Mine	1899
On site	Unspecified Mine Quarry	1898
27m S	Unspecified Pit	1899
36m SW	Unspecified Heap	1926
36m SW	Unspecified Pit	1898
40m SW	Unspecified Heap	1948

Location	Land use	Date
40m W	Unspecified Pit	1898
45m W	Unspecified Pit	1899
133m E	Ground Workings	1961
133m E	Ground Workings	1969
171m NW	Unspecified Disused Pit	1926
171m NW	Unspecified Pit	1898
174m E	Unspecified Mine	1898
179m E	Ground Workings	1969
237m NW	Iron Ore Mine	1899
237m NW	Mine	1924

Coal and associated mining

Historical land uses identified from Ordnance Survey mapping that indicate the presence of coal working. Coal mines were often also associated with the extraction of ironstone.

Location	Land use	Date
153m W	Old Coal Shaft	1926
156m W	Old Coal Shaft	1924
