Sample Site, Sample Street, Anytown, UK

Reference:  
Mockup\_Georisk

Date:  
15 January 2025

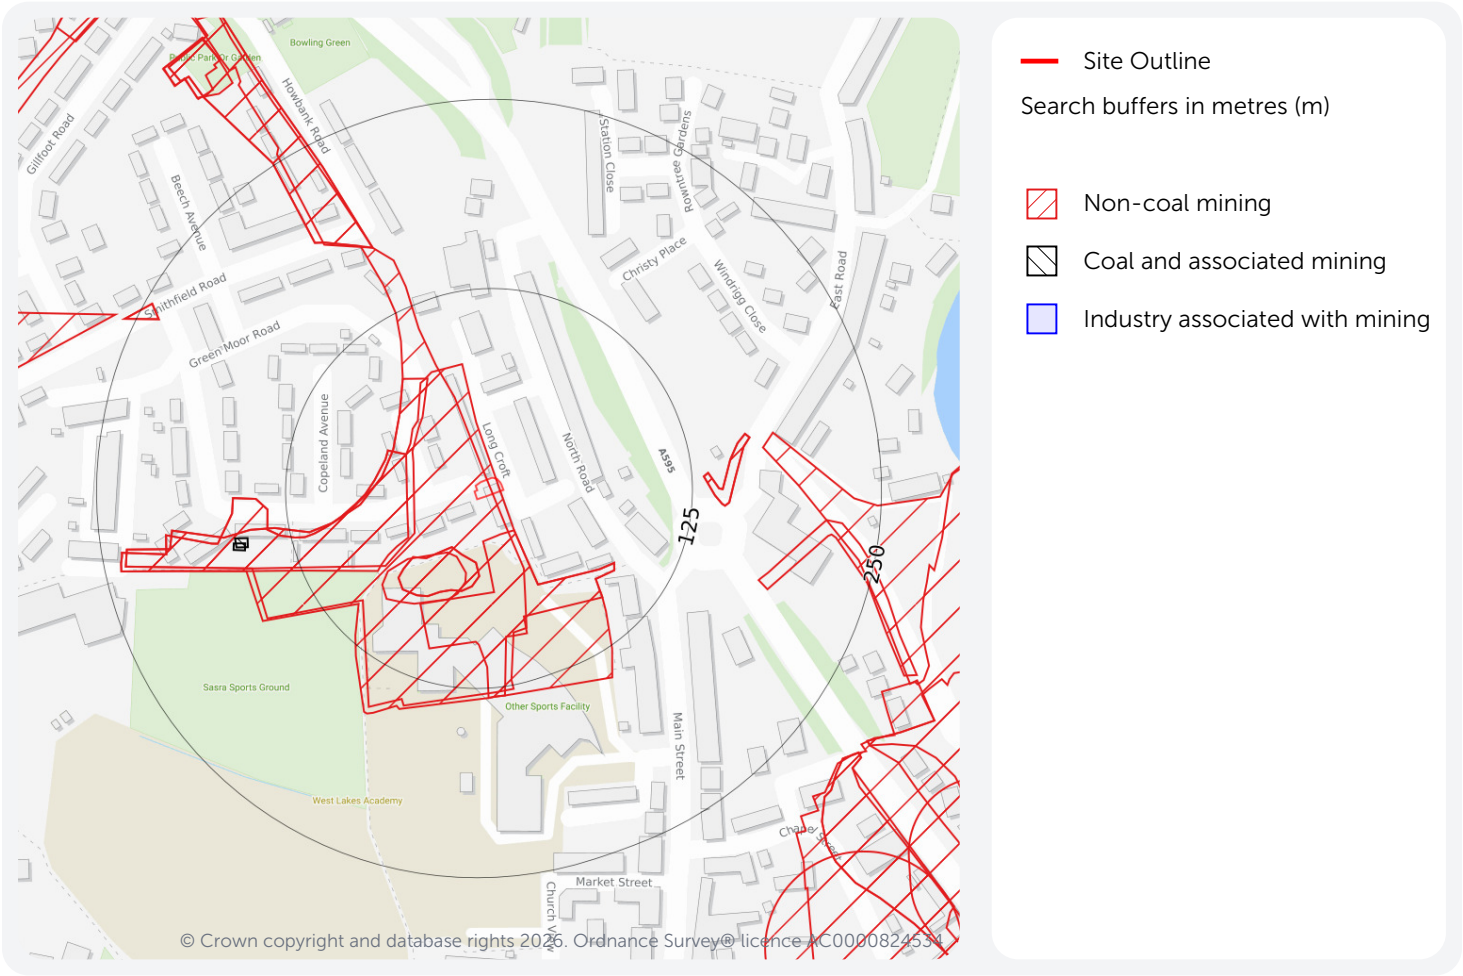
Non-coal mining

Historical land uses identified from Ordnance Survey® mapping that involved mining for substances other than coal.
